BAMBOO LATTICE ROOF SHELTERS

THE RSK SHELTER ROOF FRAME

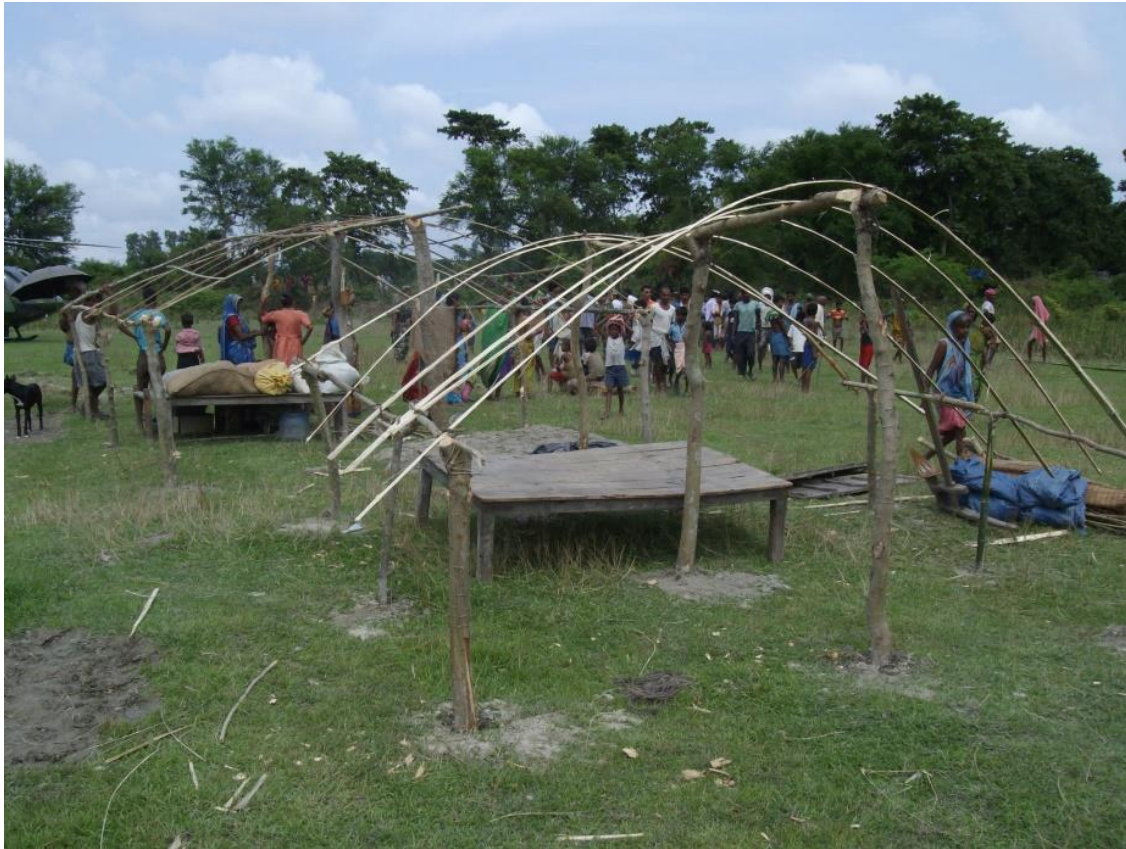
NEPAL KOSHI RIVER DISASTER

**A RELATIVELY WEAK STRUCTURE
OFTEN POORLY CONSTRUCTED**

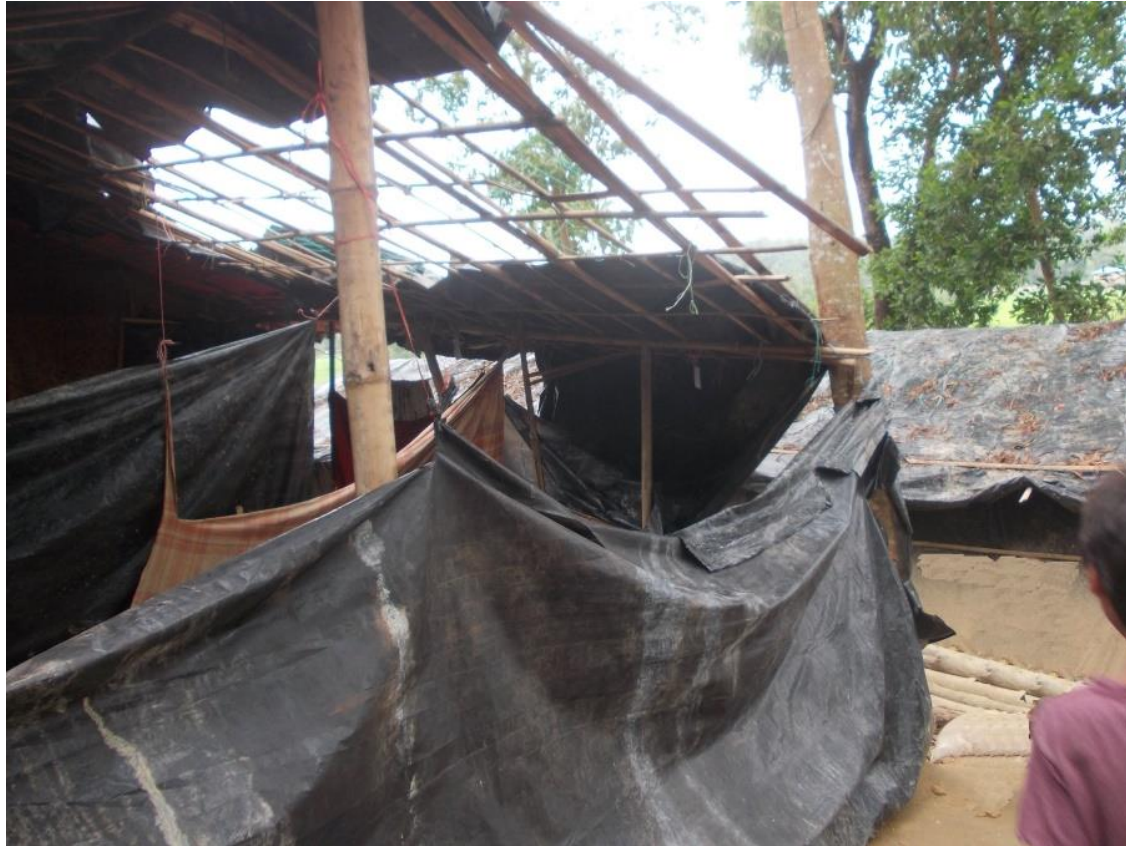
BANBLADESH ROHINGYA REFUGEE CAMP

**A ROOF THAT TAKES TIME AND SKILLS TO BUILD
WHEN DAMAGED REPAIRS CAN BE DIFFICULT**

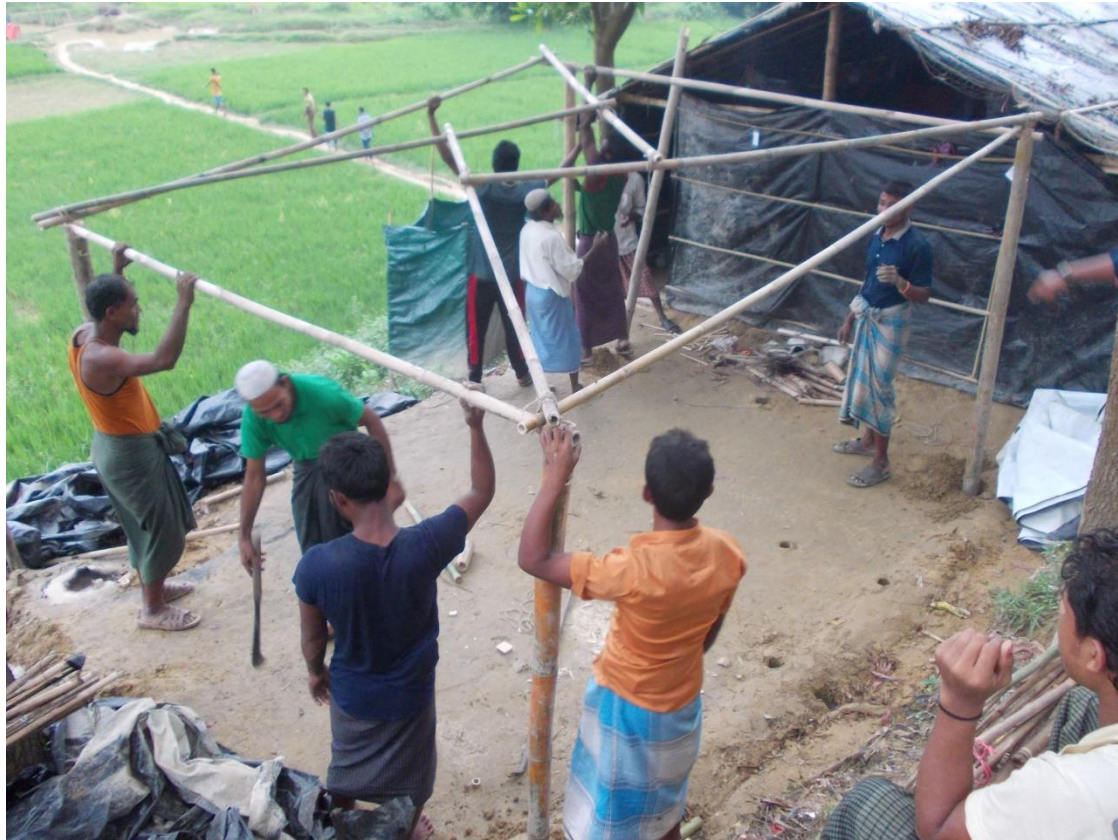
BANBLADESH ROHINGYA REFUGEE CAMP

USES ONLY STRONG BAMBOO POLES, REQUIRES MINIMAL SKILLS, IS RAPIDLY ASSEMBLED AND EASY TO REPAIR
